ANNUAL ASSESSMENT
NORTH BOUNDARY CONTAINMENT
TREATMENT SYSTEM

FY '83

Rocky Mountain Arsenal

October 1983

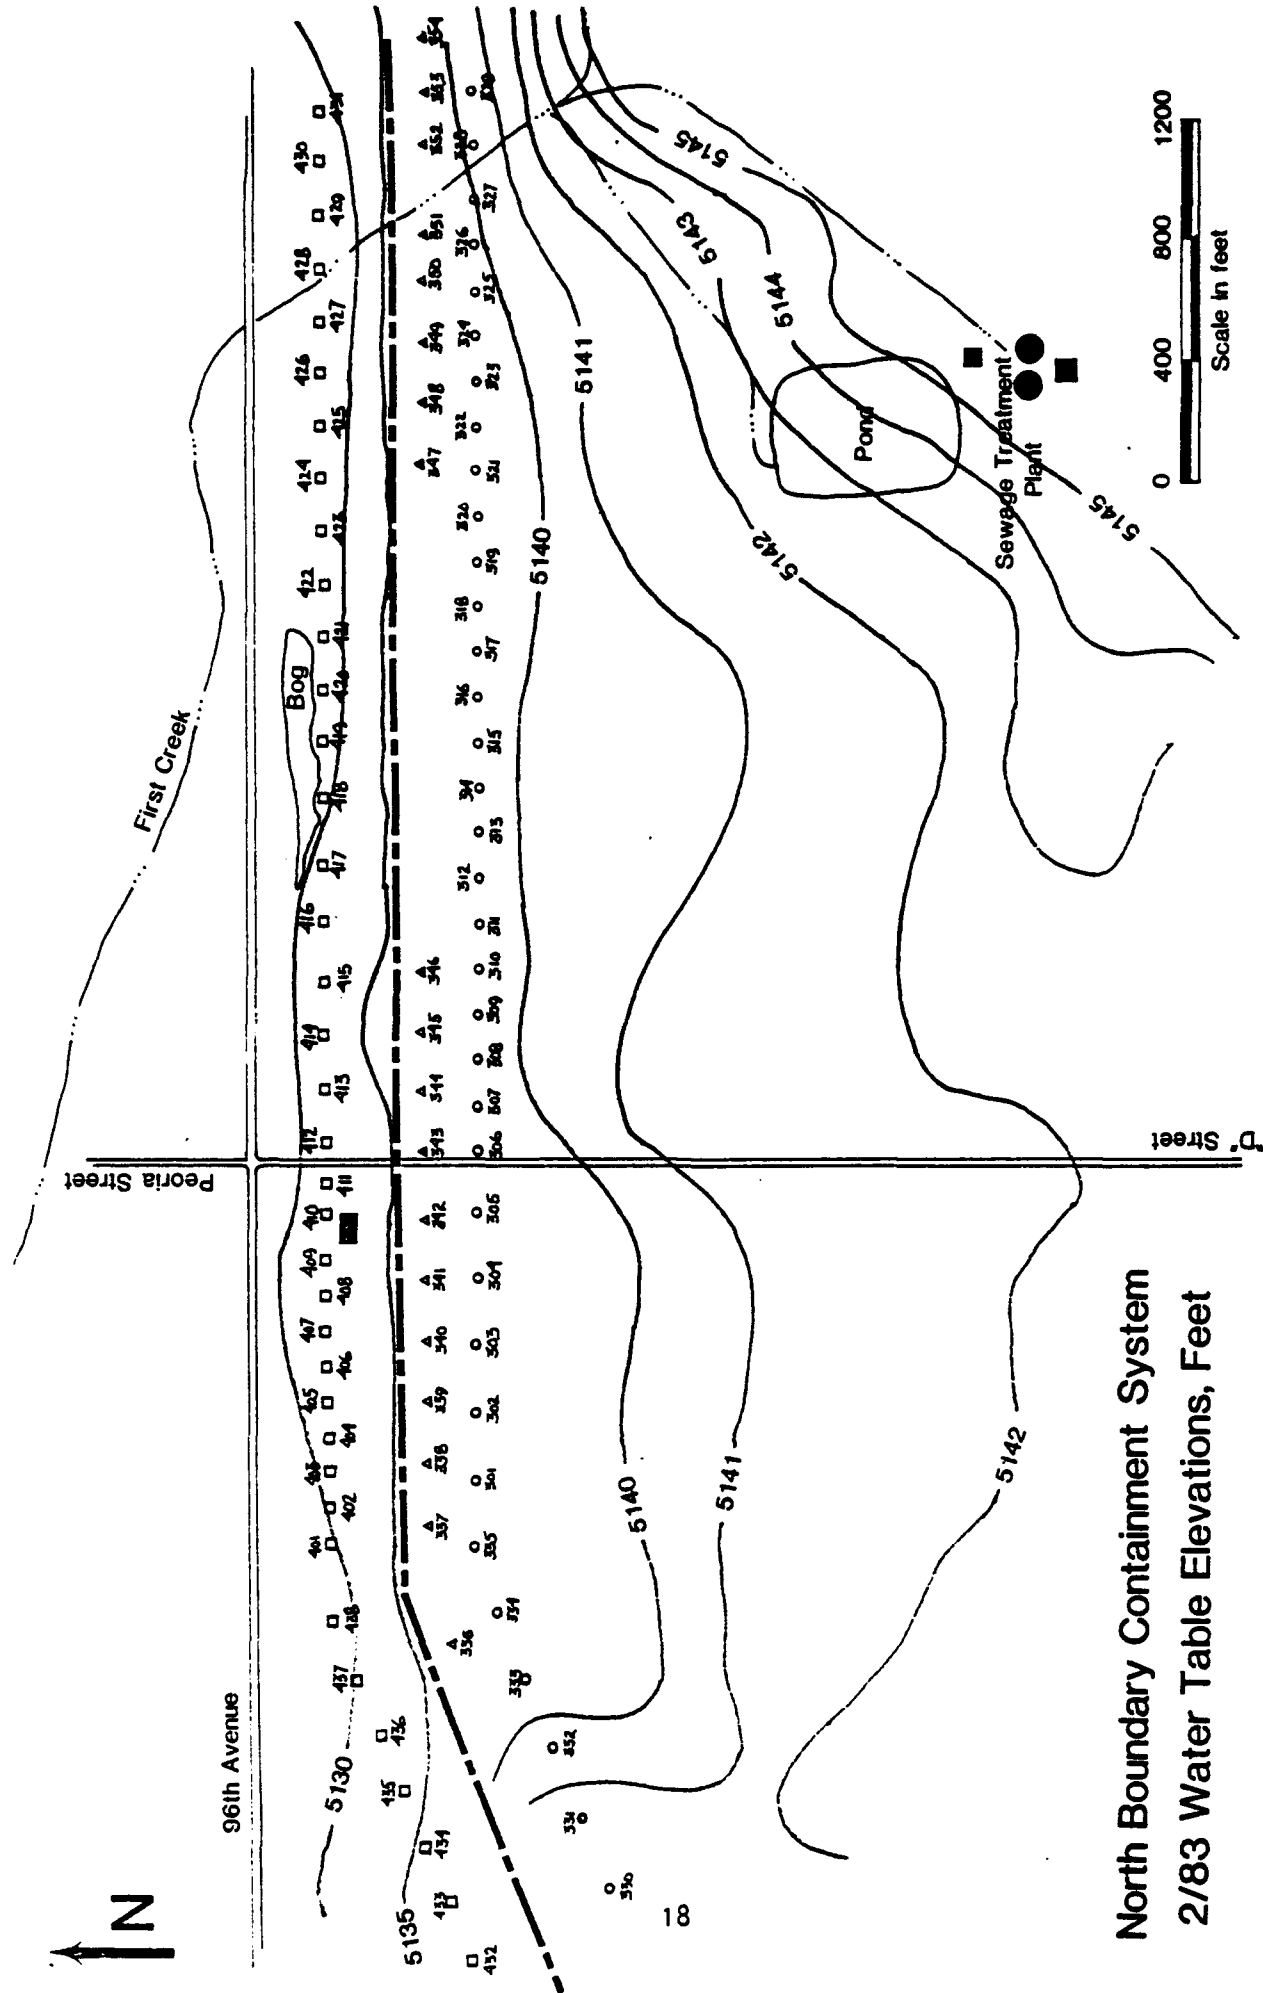
Figure 11

In general, upstream water levels have risen during the second half of 1983. Water levels were taken in both February and August 1983 (Figs 11-12) and the Arsenal map indicates a progression of the 5147 level northward. This is contradictory to the observations made with regard to production from the dewatering wells for the same period. Water level maps for years 1977, 1979 and 1983 have not been completed in time for this writing and may lend some insight as to comparative water level features before and after the installation of the expanded barrier.

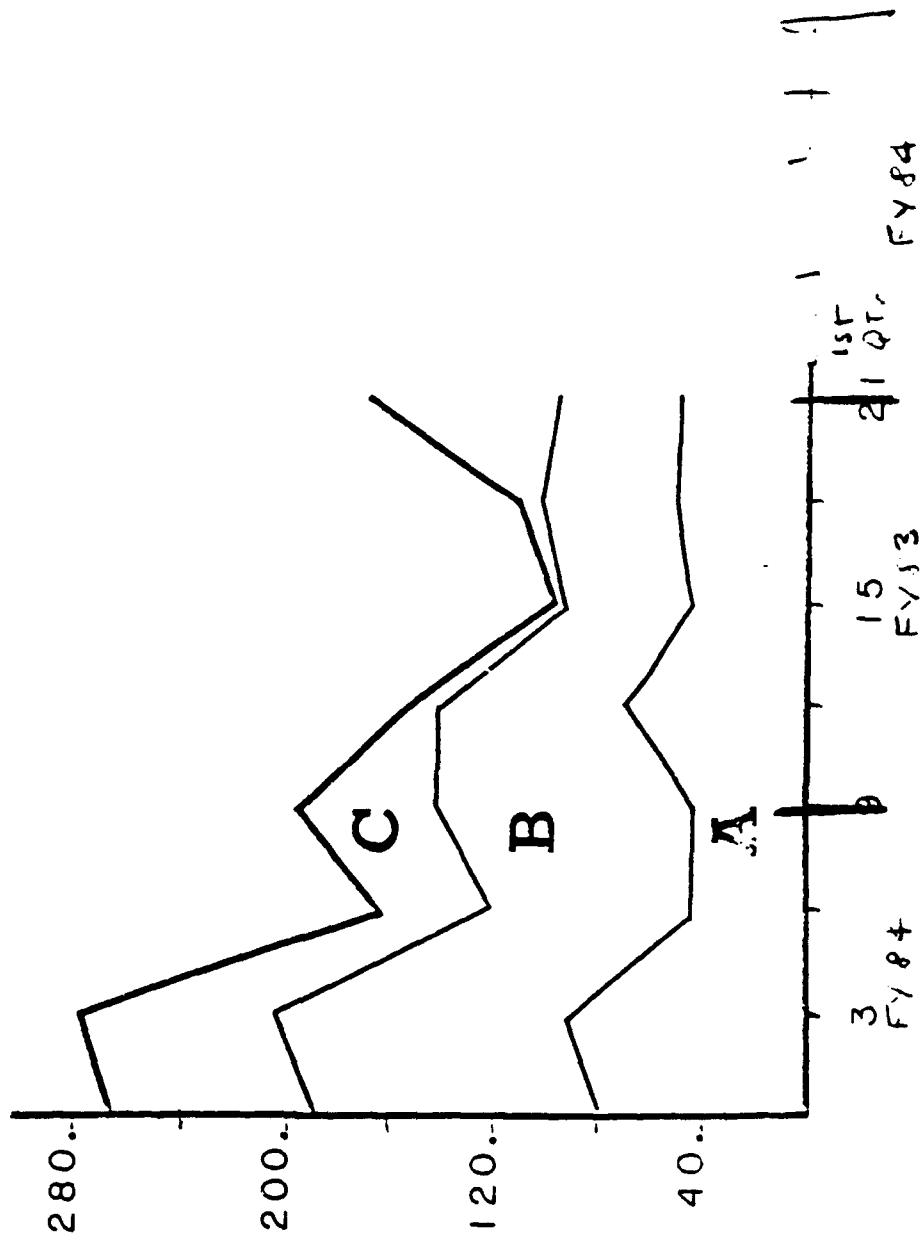
Figure 14 indicates the continued downward trend of ground water production from an average flow of 270 gpm upon system startup to 170 gpm at present. It is difficult to determine if the initial production was due to stressing of the aquifer or drawdown of backed up water due to the fact that the barrier was in place approximately six months before the startup of the entire system. At the present time, the dewatering system appears to be pumping all the water available at the wells, however, deterioration of the aquifer or well packing could also account for the reduction in production.

The most drastic change was noted in the "C" section. It appears the east end of the system does not in itself have an alluvial source, but instead, derives a majority of its flow from the sanitary sewer plant and First Creek drainage.

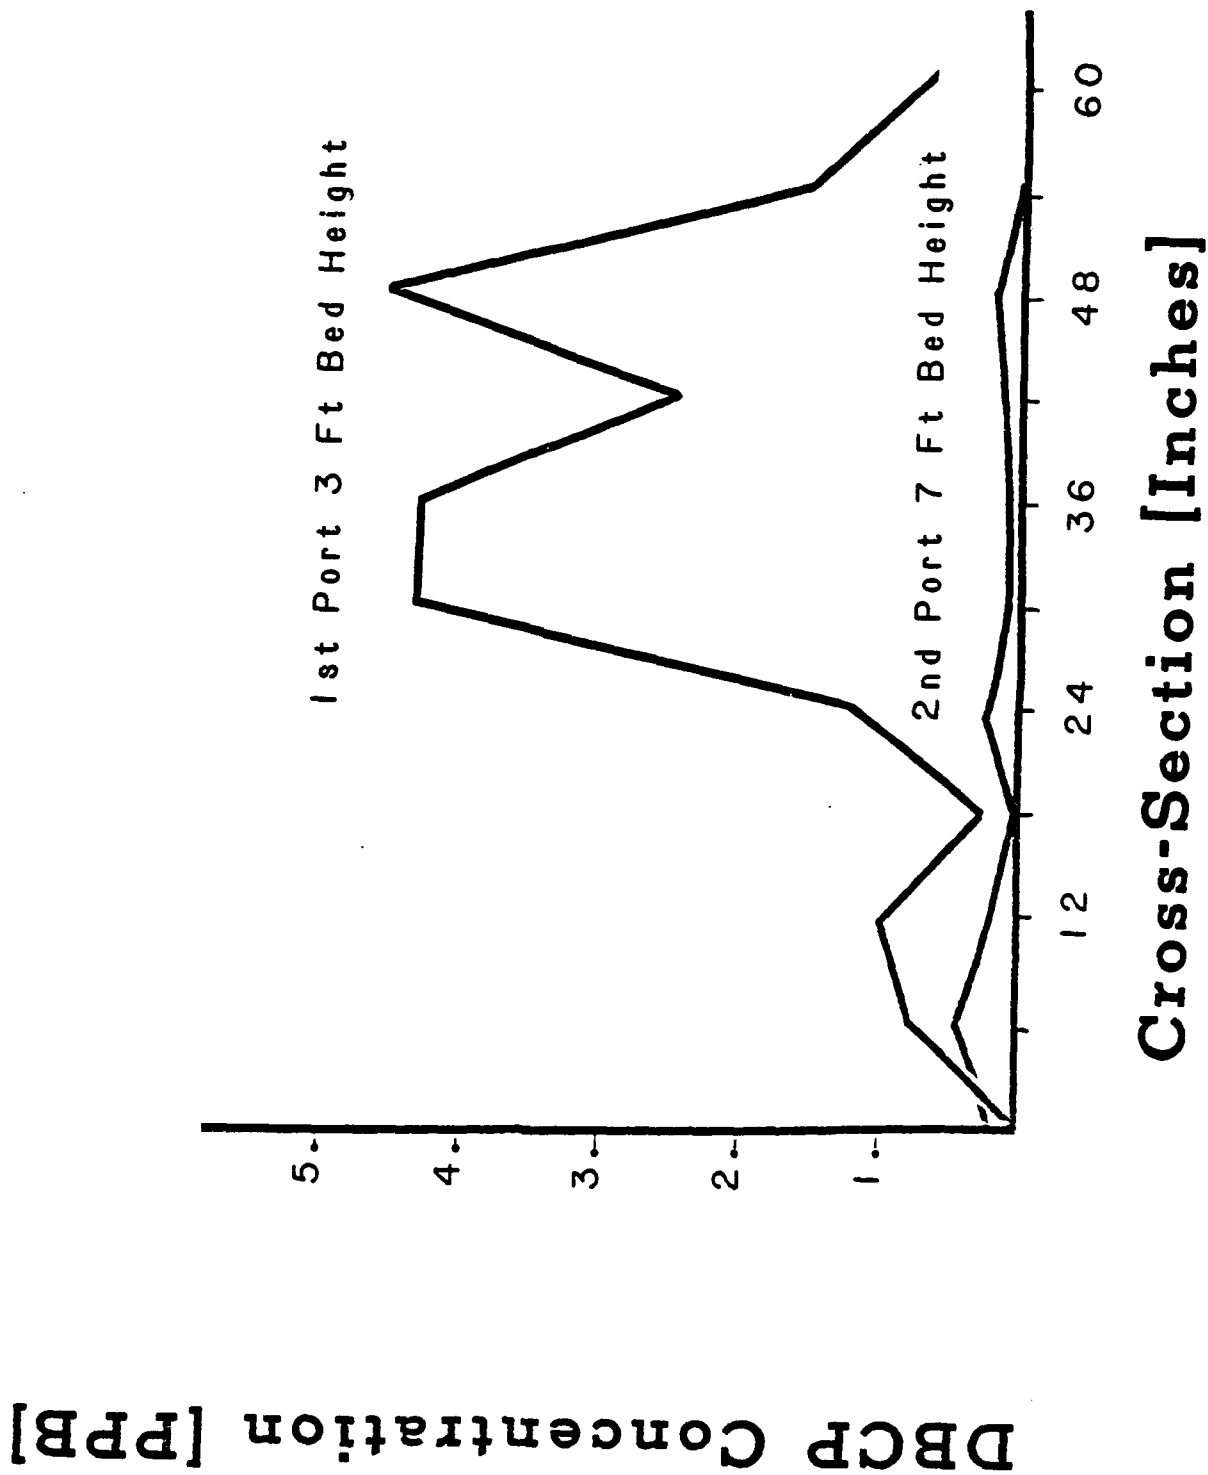
Figure 17

Studies of this nature are ongoing and lend valuable assistance in the understanding, explanation and prediction of adsorber phenomena and system efficiency.

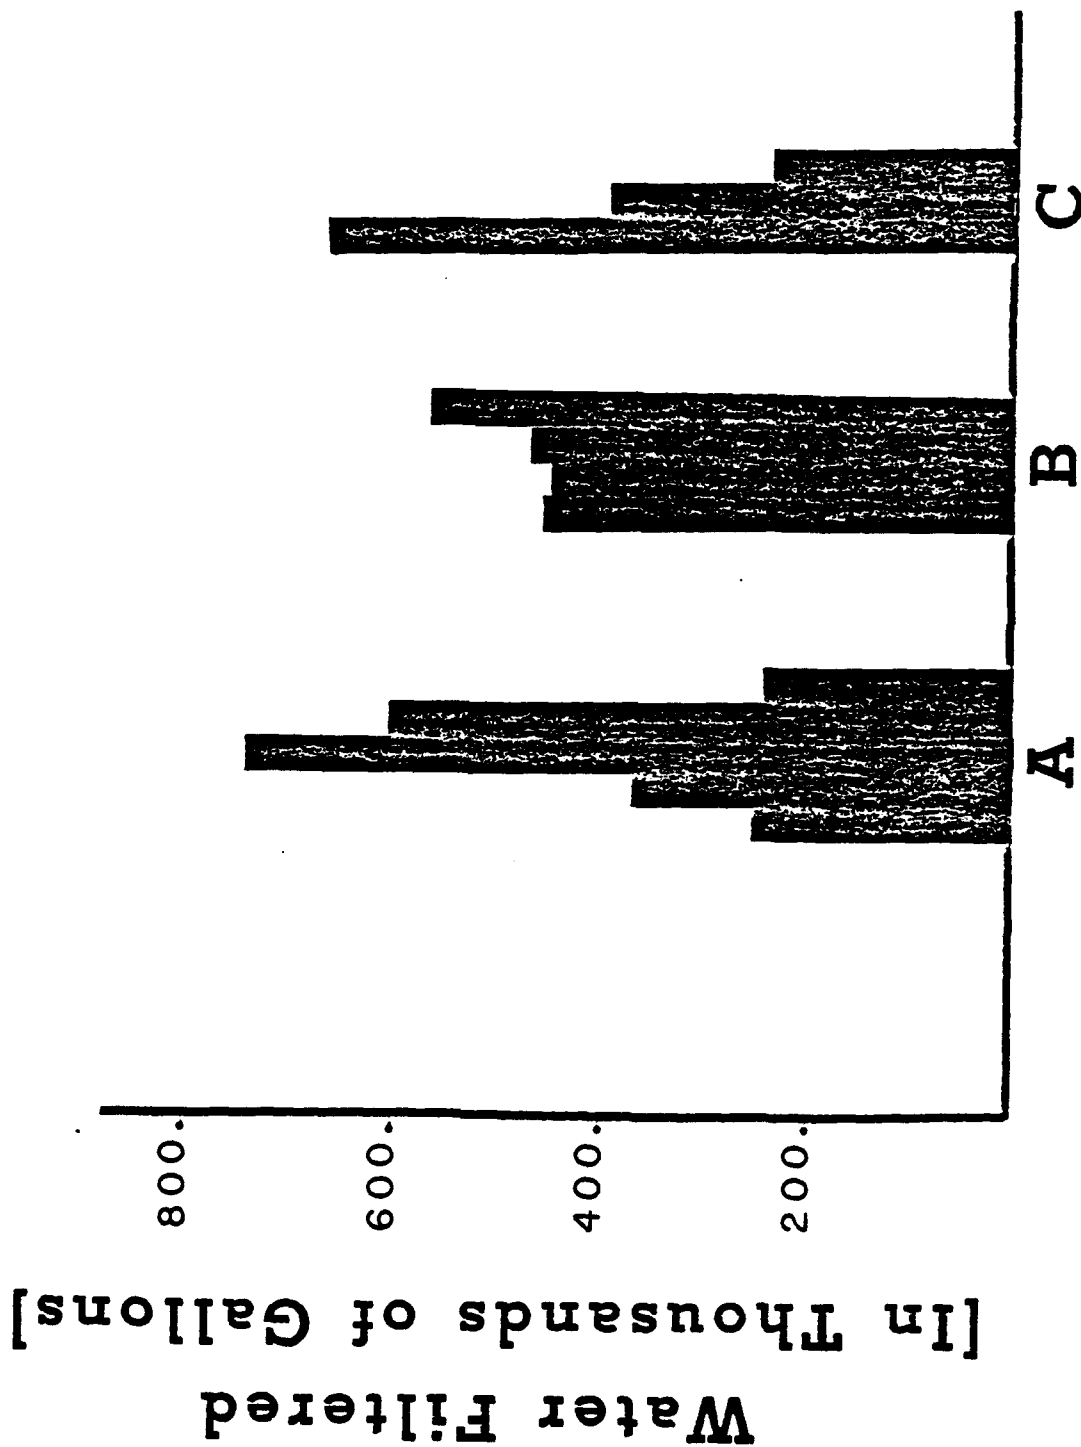
Figure 18 shows the average gallons of contaminated water strained per filter bank for each change for their respective adsorber. The "A" adsorber prefilters average ranged from 236,383 to 732,792 gallons in five different replacements. The irregular usage pattern may be attributed primarily to the recycling of the auxiliary sump waste water. Since the plant is operated in a no-discharge mode, foreign material is recycled to the auxiliary sump and after settling to the "A" feed sump. Therefore, this additional load is reflected in "A" filter replacement figures.

A more uniform pattern is reflected in the "B" adsorber prefilters. The prefilter average ranged from 446,917 to 558,658 gallons in four replacements. This variation may be caused by silt from the dewatering wells.

The "C" adsorber prefilters averaged from 653,545 to 235,588 gallons in three replacements. The decrease in capacity of each filter could be caused by well screen breakdown or a failed feeder line, neither item substantiated however. Soil observed on the filter element during replacements indicates the possibility of a ruptured feed line header.

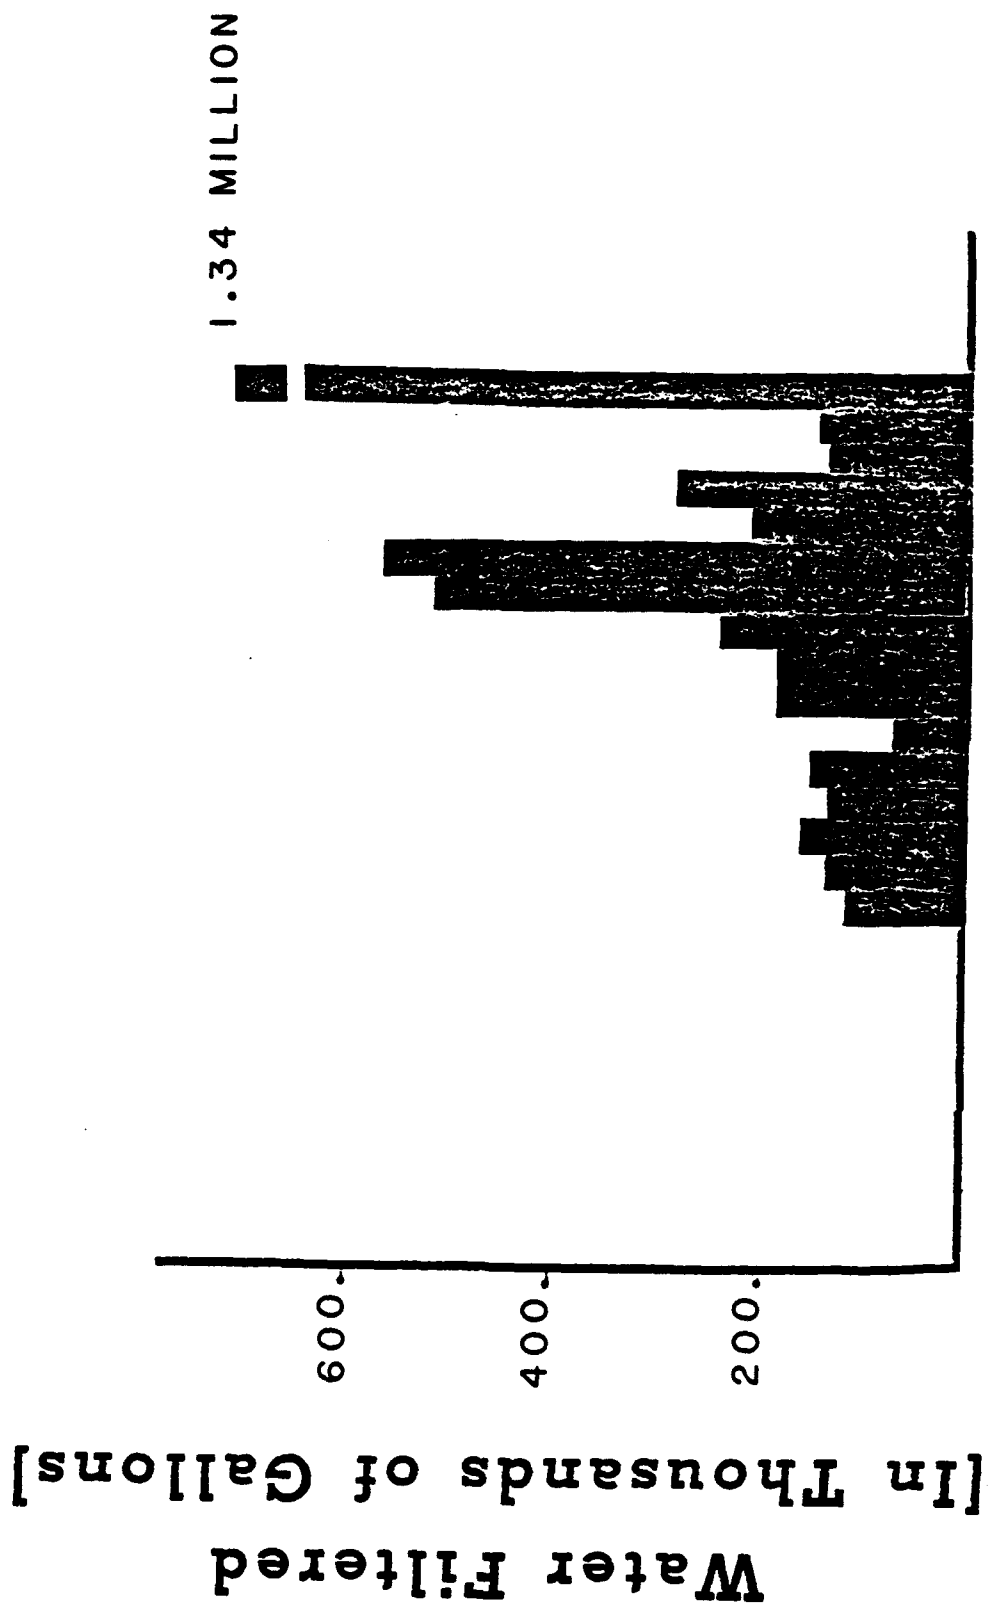
Figure 19 shows the average gallons of treated water filtered for each cartridge replacement.

The post filter average ranged from 75,871 to 1,340,000 gallons in 16 different replacements.

The high filter replacement rate was caused by carbon granules escaping through the adsorber septa sleeves. A wedgewire screen was installed in each adsorber effluent downcomer to determine which adsorber permitted the carbon

granules to escape. Tests were conducted to evaluate various septa sleeve materials. During the tests it was noted that carbon had passed through the loose mesh material installed in "A" and "C" adsorbers. "B" adsorber septa sleeves are of a tight weave material and no carbon granules were observed on the screen. During June 1983 all sleeves were inspected and replaced where necessary with tight weave material.
